THE STORM AS A TEACHER:

Lessons in Preparedness from Hurricanes Ike and Rita

By Calvin Powitzky

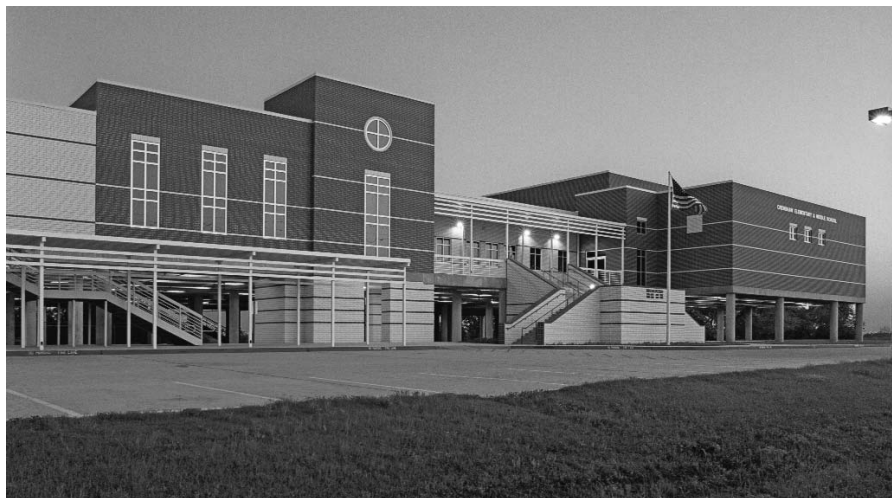
Crenshaw School – sole survivor of Hurricane Ike

ocean, it was elevated above grade and designed to withstand a 140 MPH wind load. Crenshaw was the only commercial building on Bolivar Peninsula to survive the storm as the hurricane's eye passed directly over the town. In fact, in the aftermath of Ike, Crenshaw immediately became a regional relief headquarters for FEMA, the County of Galveston, and the State of Texas, providing greatly needed assistance to the devastated area.

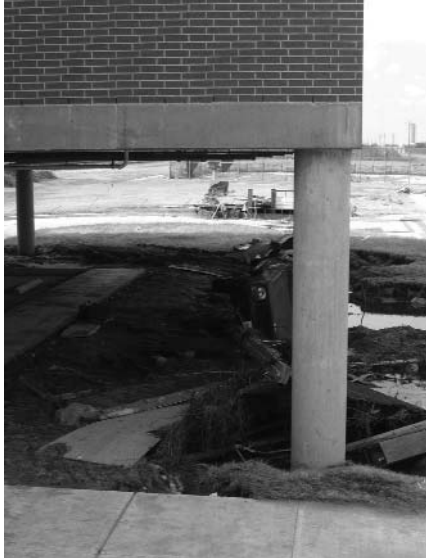
In an area of extreme devastation, Crenshaw School stands up to Hurricane Ike.

- A roof assembly consisting of a poured, insulated, lightweight concrete deck with a fully adhered, multi-ply roof system. Because this design had little reliance on mechanical fasteners, it proved to be superior to mechanically-fastened / rigid insulation roof assemblies and metal roofing systems. Roof failures accounted for more than 75% of the destructive cost of Hurricane Ike.
- Additionally, rooftop equipment was installed with supplemental anchoring to prevent becoming airborne debris.
- An elevated, cast-in-place concrete slab, rising 18 feet above grade and several feet above coastal code requirements. Having a mostly unobstructed area below the building allowed for the estimated 16 foot storm surge to pass safely below the building, rather than into it.
- All glass doors and windows were designed with curtain wall type framing with 9/16 inch

large missile impact resistant safety glass. Although the glass areas were left unprotected during the storm, there was not a single failure of any glazed assemblies.
